HUDSON RIVER BASIN
CLOVE BROOK, SUSSEX COUNTY
NEW JERSEY

LEVEL
CLOVE RIVER DAM
NJ 00035

PHASE 1 INSPECTION REPORT
NATIONAL DAM SAFETY PROGRAM

Clove River Dam (NJ-00035). Hudson River
Basin, Clove Brook, Sussex County,
New Jersey. Phase I Inspection report.

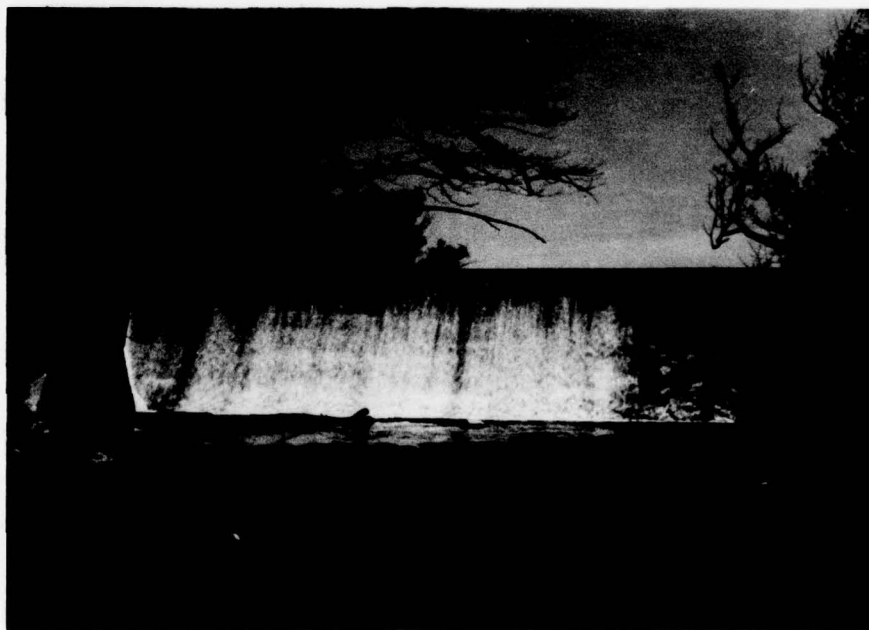
Photo No. 2 - View of spillway from downstream.

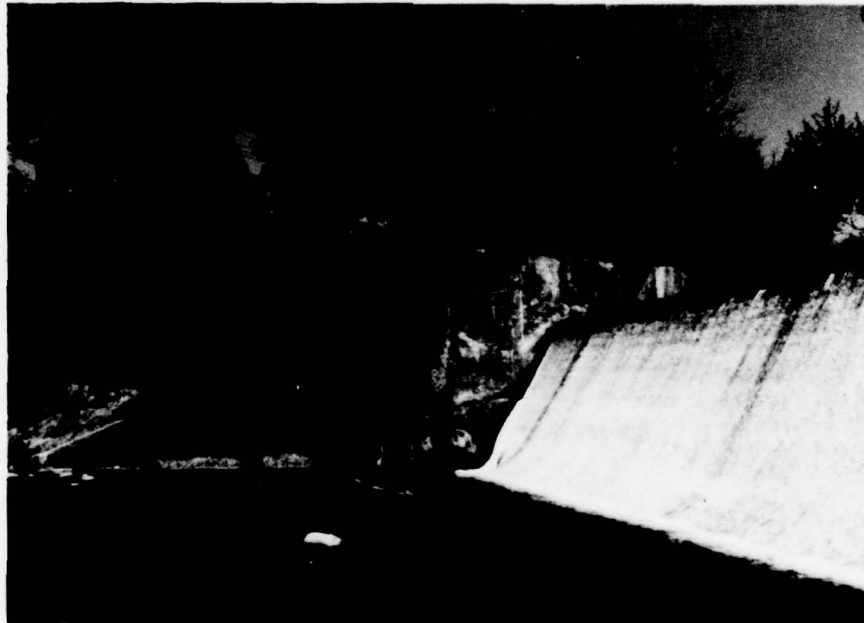
Photo No. 4 - View of right wingwall. Note the seepage from the drains and the minor erosion of concrete at the water-line.

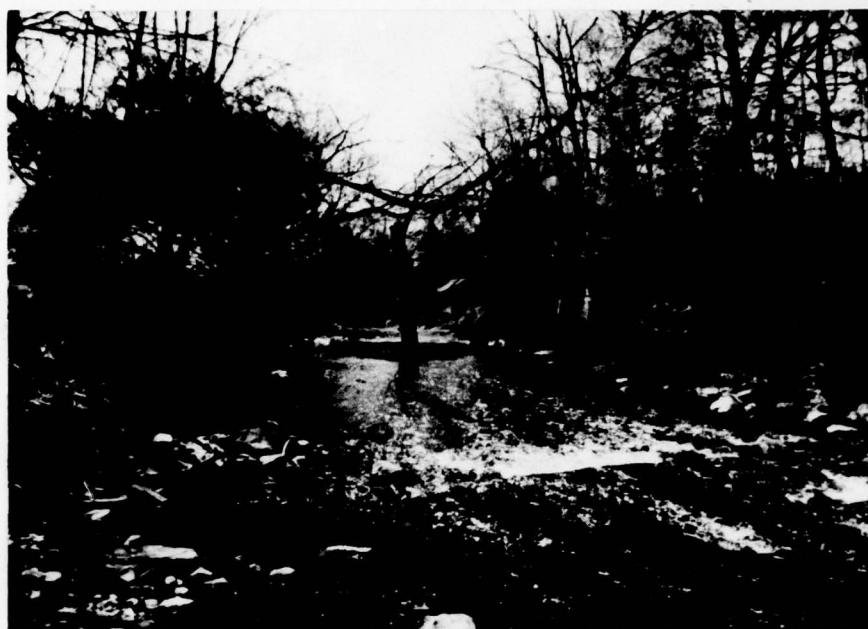
Photo No. 11 - View of downstream channel showing the old bridge structure from which the deck has been lost.
